SAFETY WARNING! PLEASE READ! Important Safety Notice regarding Fluke 8x V Series Digital Multimeters

Fluke Corporation has identified a potential safety issue affecting certain Fluke 83V, 87V and 88V Digital Multimeters ('Fluke 8x V series DMMs').

ISSUE DESCRIPTION:

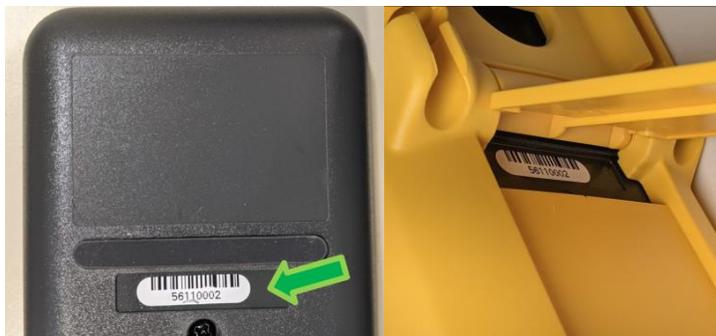
A. Identify your product serial number

If you cannot locate the serial number on your Fluke 8x V series DMM, or if the serial number is illegible, please follow the actions indicated in this Safety Notice in paragraphs B and C below.

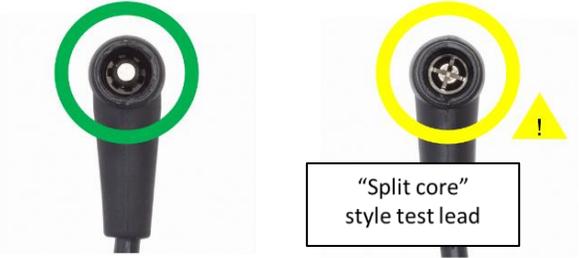
“Lantern spring” style test lead

NOTE – The Fluke “lantern spring” style test leads¹ fully inserted have been shown to maintain sufficient contact to prevent the identified potential safety issue. Therefore, if your meter requires service for this issue, but cannot be sent in immediately, the meter may continue to be used with Fluke “lantern spring” style test leads until the unit can be serviced. See images. All other safety requirements for the use of your DMM and test leads of course remain applicable.

¹ All Fluke TL75 and TL175 test leads sold separately as accessories are “lantern spring” style test leads.

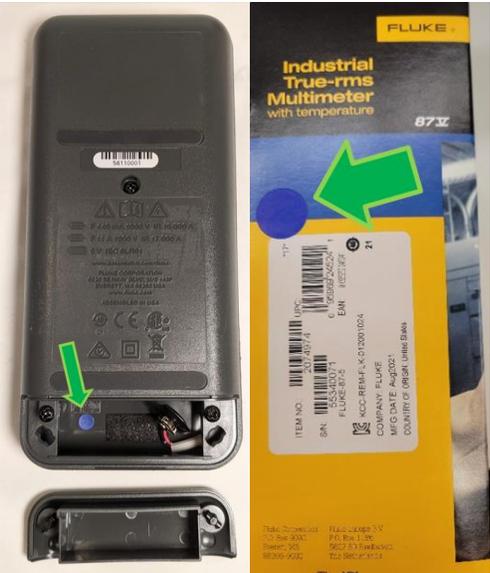
– Note –
Units in the defined serial number range that had the issue corrected prior to shipment or through service can be identified by a blue or green sticker in the battery compartment and on the unit packaging:
